## ARE YOUR SILO ROOFS FAILING?

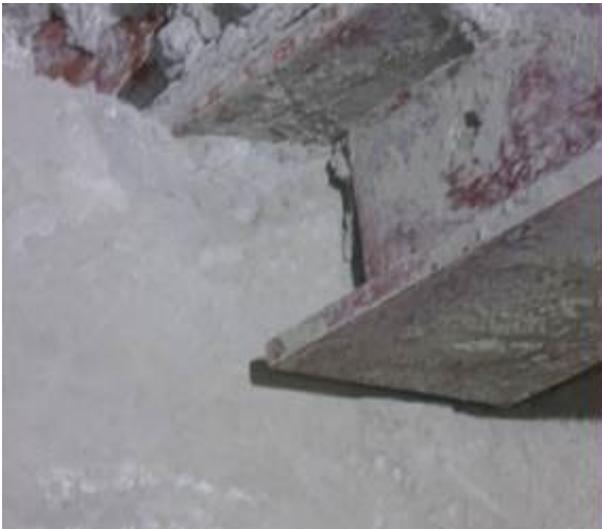
The roof beam supports should have been designed to accommodate for thermal expansion. This is accomplished by allowing the roof beam base plates to freely slide in the longitudinal direction over an embedded steel plate on the wall beam pockets.

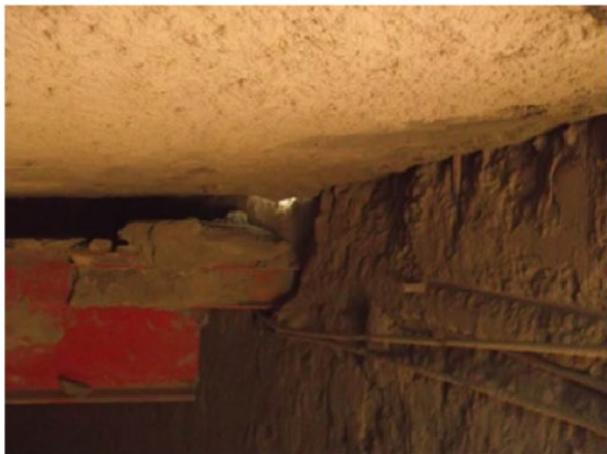
The embedded plates that support the roof beams are usually involved in the failure process. Weather and temperature changes cause the concrete walls to deteriorate faster around the beam pockets than the rest of the silo walls. Such deterioration leads to spalling and loosening of the bond between the embedded steel anchors and the concrete walls. When such conditions occur, the roof supporting steel beam will eventually rest on unprotected concrete. The constant thermal movement of the beam, combined with the dead and live loads applied on it, results in a grinding force between the beam's base plate and the silo wall with the

eventual result of breakage of a part of the silo wall immediately under the beam. When this happens, the beam shifts downward until it rests again on a solid portion of the silo wall. The roof slab then deflects, at which time the failure is usually noticed by the operators.
